City of Garden Grove

Banner Pole Condition Assessment

Garden Grove, CA
November 7, 2019

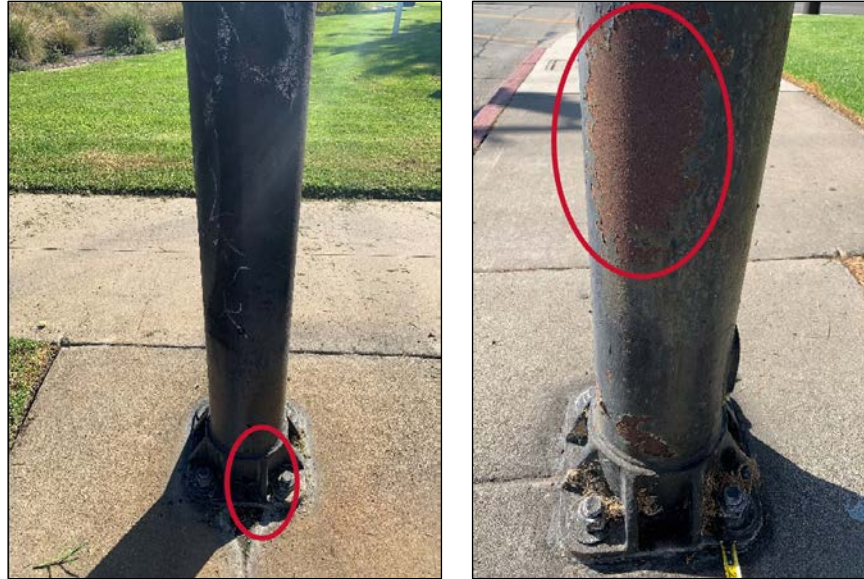
Coating delamination was observed in places on the west banner pole. Light uniform corrosion was observed at points of coating failure. No severe or through-wall corrosion damage was observed. The inside of the west pole could not be examined.

Coating was intact and no external surface corrosion was observed on the east pole. No severe or through-wall corrosion damage was observed. The end flange included a weep hole to allow moisture to exit the inside of the pole. This hole appeared to be partially plugged with corrosion product.

The average of all UT measurements on the east pole was approximately 0.36-inch. The average of all UT measurements on the west pole was approximately 0.38-inch. The complete set of UT data is shown in Table A1.

Figure 3 – East Banner Pole (Left), West Banner Pole (Right), Site #1

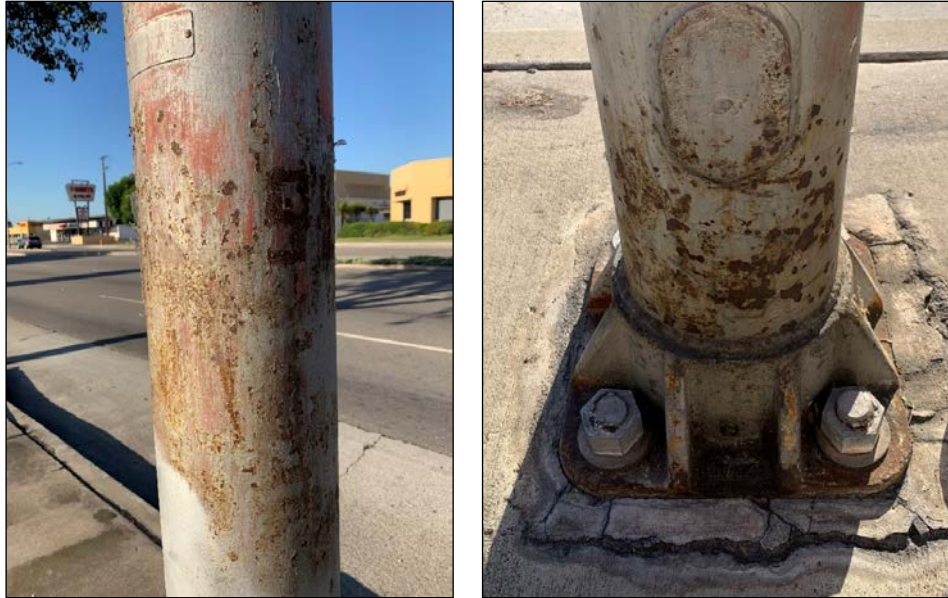
Areas of flaking paint were observed on both the east and west poles. In many areas where paint was missing, the underlying galvanized coating had also failed, allowing both uniform and pitting corrosion to occur on the outer surface. No severe or through-wall corrosion damage was observed on either pole. Most of the observed corrosion damage on the east pole was located approximately five feet above the ground. The majority of corrosion on the west pole was located on the lower portion of the pole near the flange. The internal surfaces could not be examined on either the east or west pole. The concrete around the west banner pole was cracked, possibly from loading due to tension from the steel cable attached to the top of the pole and/or deficiencies in anchor depth.

The average of all UT measurements on the east pole was approximately 0.39-inch. The average of all UT measurements on the west pole was approximately 0.41-inch. The average of all UT measurements on the pole in the median was approximately 0.22-inch. The complete set of UT data is shown in Table A1.

Figure 4 – East Banner Pole (Left), West Banner Pole (Right), Site #2

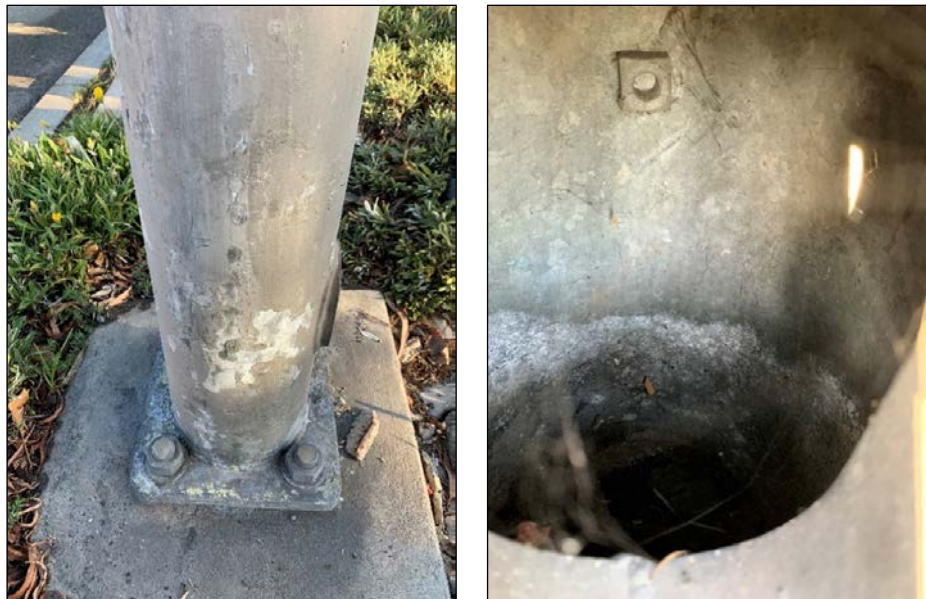
The pole in the median did not show signs of external corrosion but did show signs of flaking paint. The underlying galvanized coating appeared to be protecting the pole from corrosion at points of coating damage/degradation. The galvanized coating was intact on visible portions of the interior of the pole, protecting the interior surfaces from corrosion.

Figure 5 – Exterior and Interior Surfaces of Median Banner Pole, Site #2

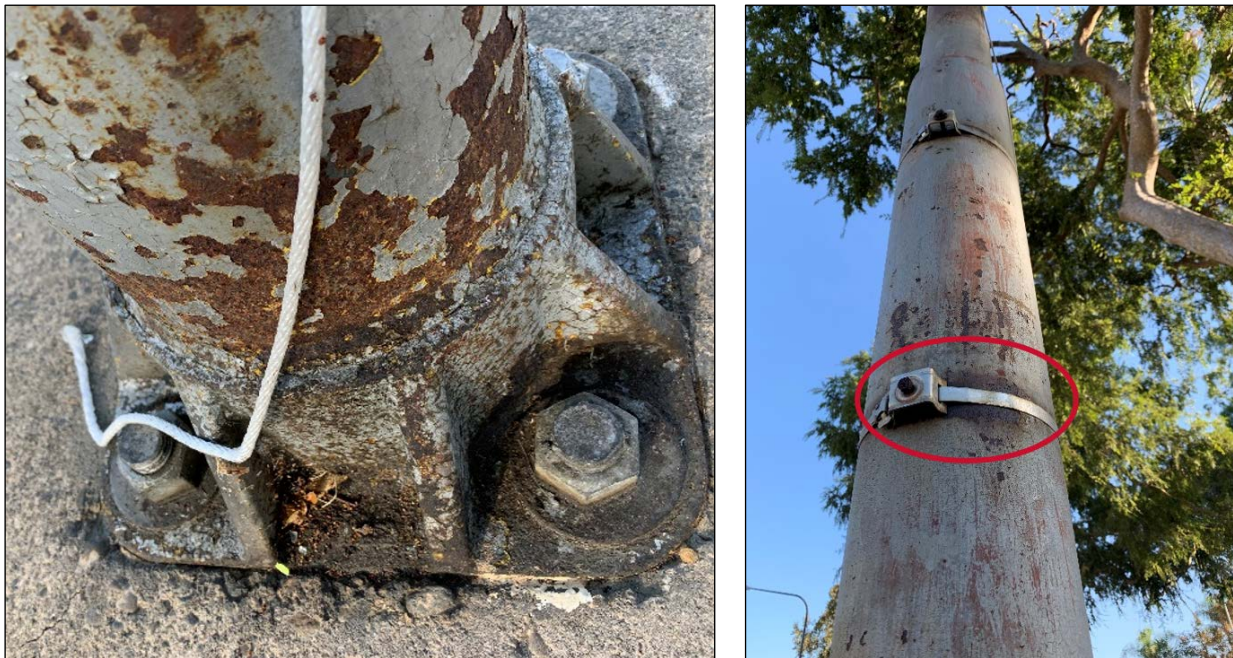
Chips and other areas of coating failure were observed on both poles. At points of coating failure, the underlying metal surface had suffered uniform corrosion. The majority of corrosion damage on the east banner pole was located on the lower ten feet of the pole. Damage was particularly

significant at the base. Some areas of pitting and uniform corrosion were observed under the street sign straps where the paint had been scraped off. No severe or through-wall corrosion damage was observed.

Figure 6 – Corrosion on East Banner Pole, Site #3

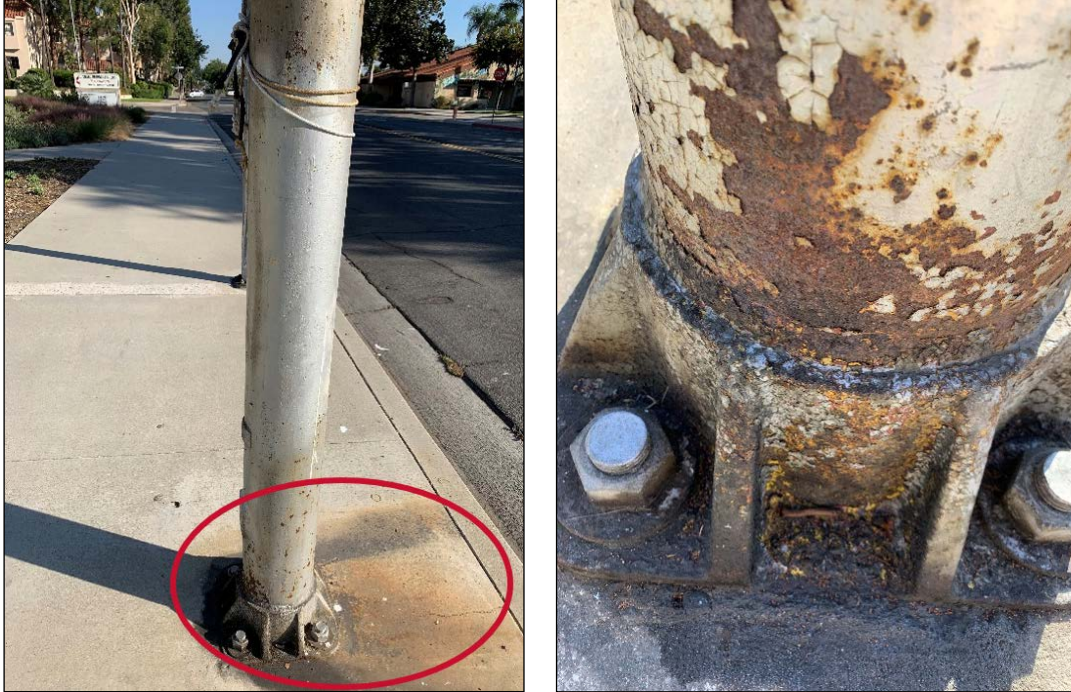
Significant corrosion damage was observed on the base of the west banner pole. The sidewalk around the flange was stained with corrosion product. A weld repair of a hole in the west banner pole was observed approximately four-feet above the sidewalk on the west side of the pole. The weld repaired areas appeared to be intact with no significant corrosion damage.

Figure 7 – Rust Stains and Corrosion on West Banner Pole, Site #3

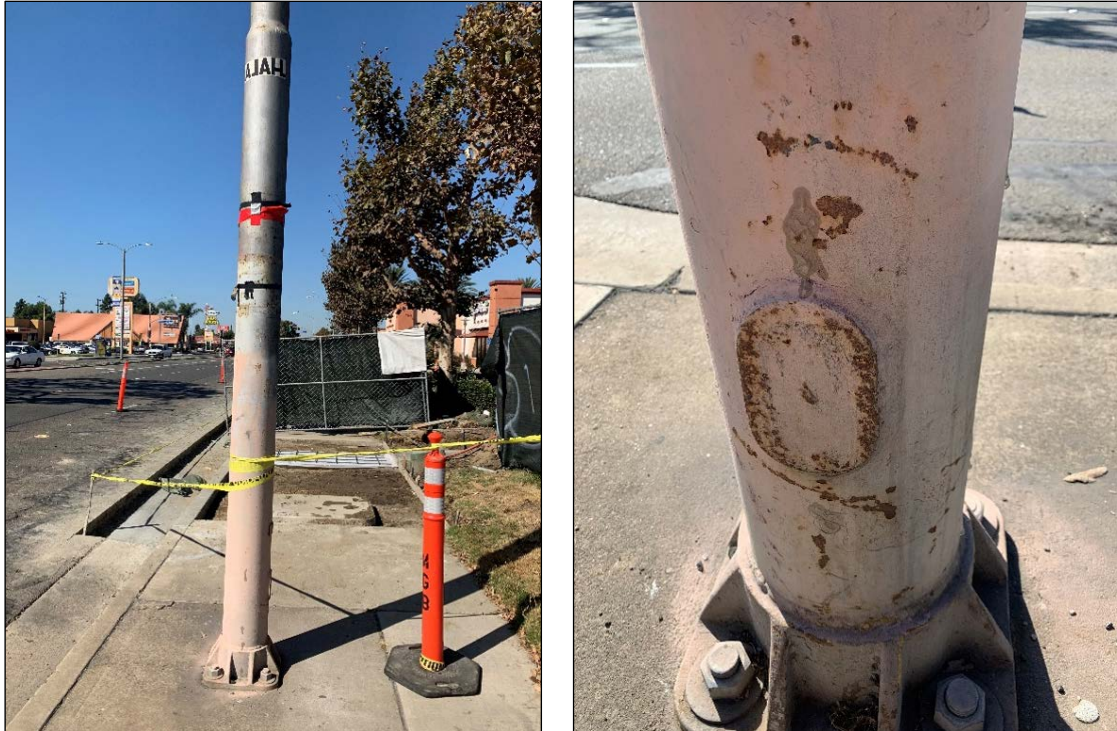
The lower portions of both poles were coated with a light pink paint. Minor uniform corrosion and pitting were observed on the external surface of the north pole. No severe or through-wall corrosion damage was observed. The end flange on the north pole included a weep hole to allow moisture to exit the inside of the pole. This hole appeared to be clean with no corrosion product.

Figure 8 – Corrosion Damage on North Banner Pole, Site #4

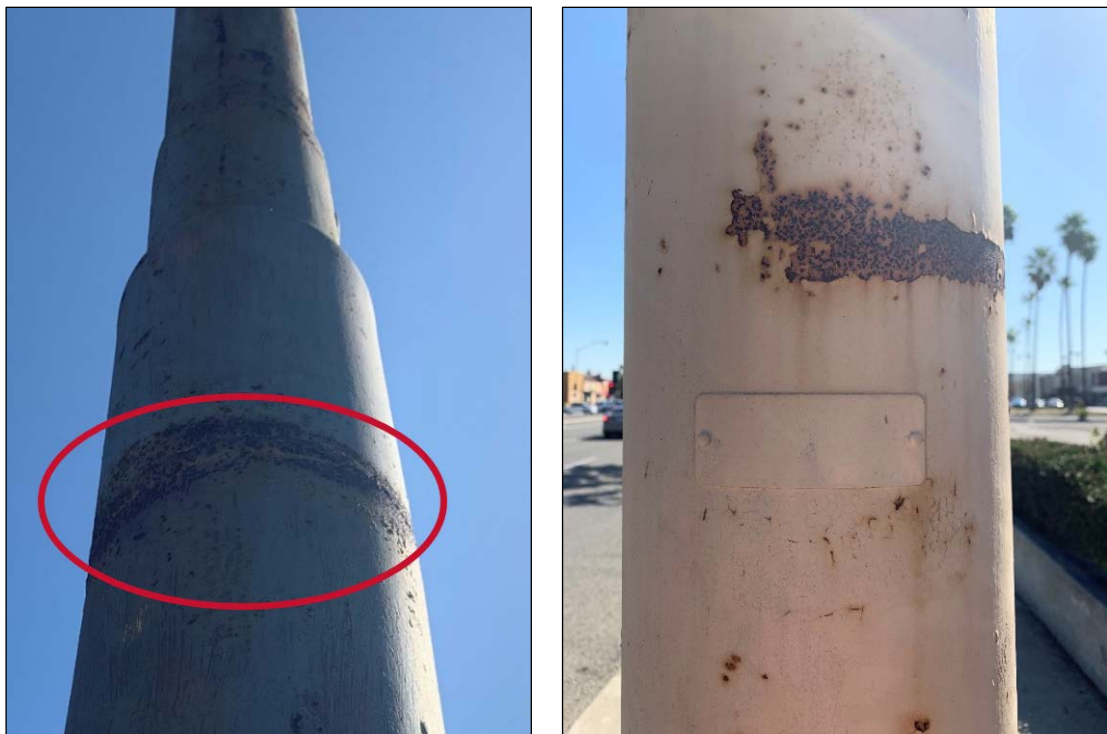
Surface corrosion was more significant on the south pole than on the north pole. Coating failure and uniform corrosion were observed at an area approximately 10-feet off the surface of the sidewalk at a circumferential weld in the pipe used to fabricate the south pole. No severe or through-wall corrosion damage was observed. A slight bend was evident in the pole at this weld (Figure 10). The bend may have been caused by force from the steel cable, fabrication error, or other damage during shipping or installation.

Figure 9 – Corrosion at Weld (Left) and Above Manufacturer's Label (Right), South Banner Pole, Site #4

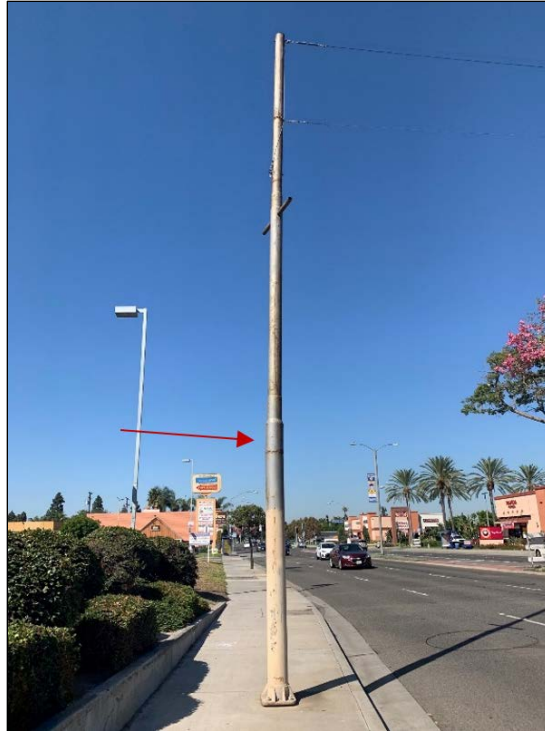
Figure 10 – Bend in South Banner Pole, Site #4

- At Site #4 (Chapman Avenue, West of Brookhurst Street), replace the existing banner pole on the south side of the street prior due to damage (bend in pole).
- At Site #5 (Chapman Avenue, East of Valley View Street), replace the existing banner pole on the north side of the street due to damage (dents from automobile collision).
At Site #7 (Euclid Street, North of Stanford Avenue), assess rusting steel reinforcement observed on the interior of the pole for structural stability. If reinforcement is not significantly corroded and pole is deemed structurally stable, repair mortar around reinforcement to prevent further water intrusion and corrosion. If rusting reinforcements are structurally compromised, replace the pole.

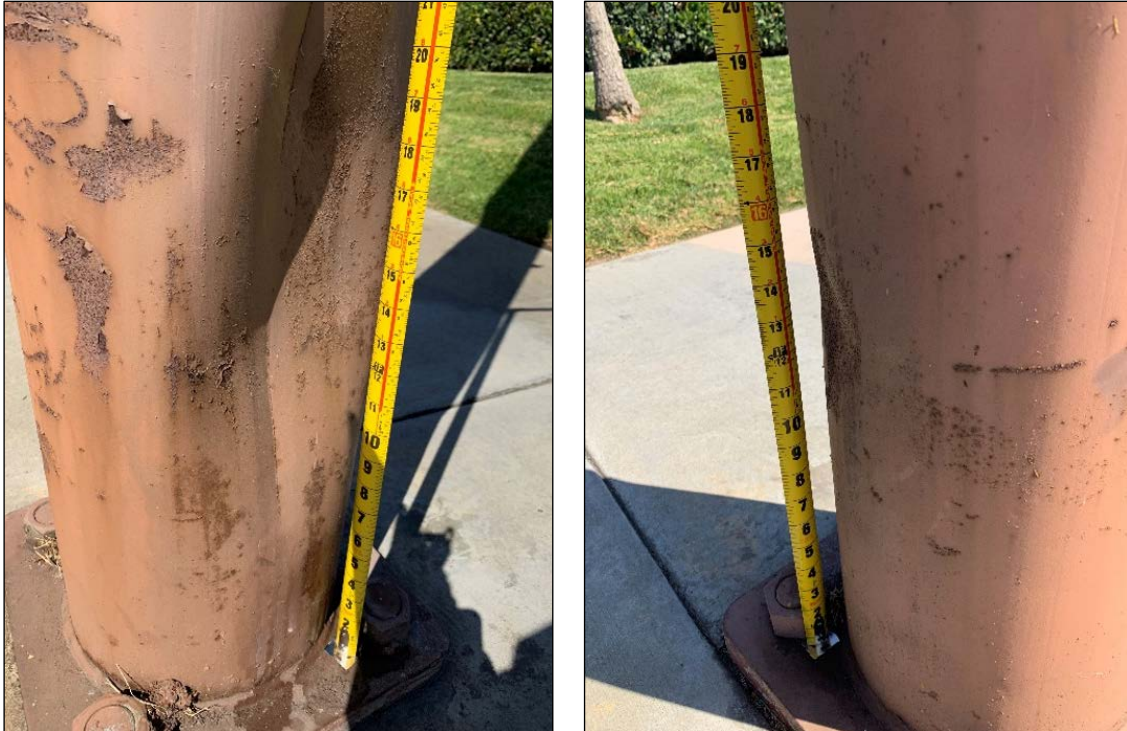
Coating delamination was observed in places on the north pole. Light uniform corrosion was observed at points of coating failure. No severe or through-wall corrosion damage was observed. Several dents, apparently from vehicular collision, were observed on the east and west sides of the north pole. The damage did not appear to be significant, but the pole was not subjected to any formal structural analysis.

Figure 11 – Dent and Corrosion Damage on North Banner Pole, Site #5

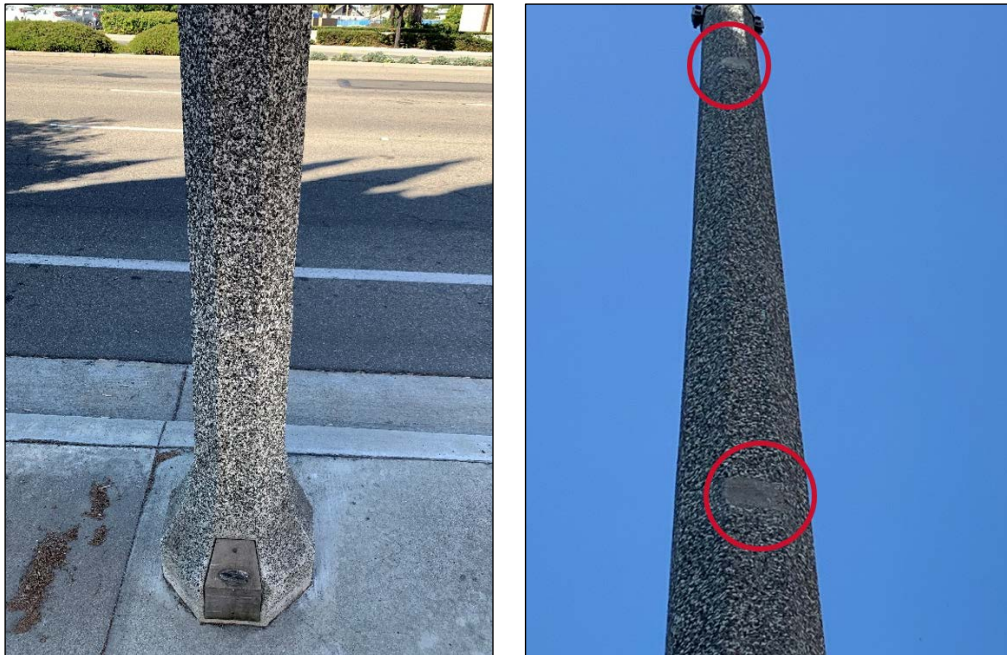
Site #6 included a single concrete banner pole located on the east side of Brookhurst Street (Figure 13). Evidence of a banner pole on the west side of the street was observed, but the pole on the west side was missing. The base of the east pole was embedded in the concrete sidewalk. The base was approximately 18 inches in diameter at the sidewalk and tapered in diameter with elevation up the pole. No steel cable was connected to the banner pole. The pole was over five feet away from irrigation sprinklers. No cracks were evident in the pole as observed from the sidewalk. Two holes that had been filled in with cement or putty were observed on the upper east side of the pole.

Figure 13 – Cast Concrete Banner Pole, Site #6

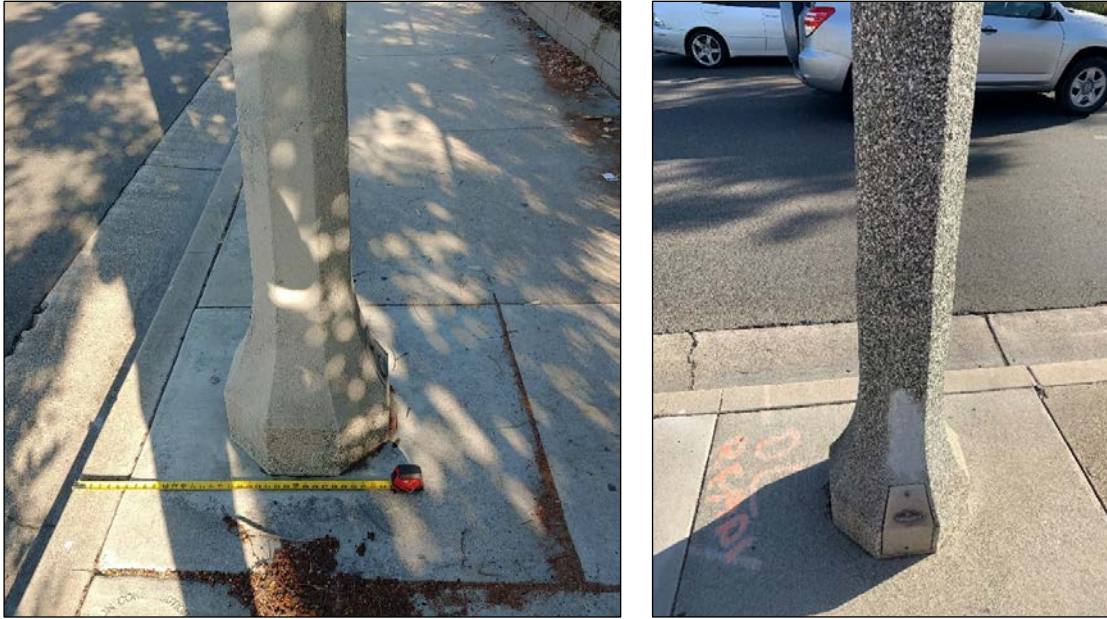
There were no signs of cracking on the exterior of either the east or west pole as observed from the sidewalk. Small cracks were observed in the interior of the pole in the median. These cracks had exposed steel reinforcement in two locations. Corrosion product was observed below both of these cracks.

Figure 14 – East Banner Pole (Left), West Banner Pole (Right), Site #7

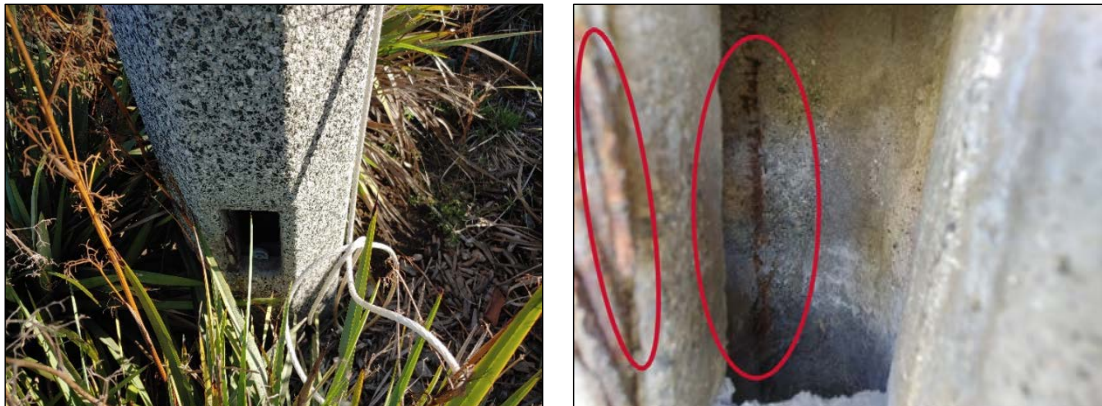
Figure 15 – Corrosion of Reinforcing Steel in Banner Pole in Median, Site #7

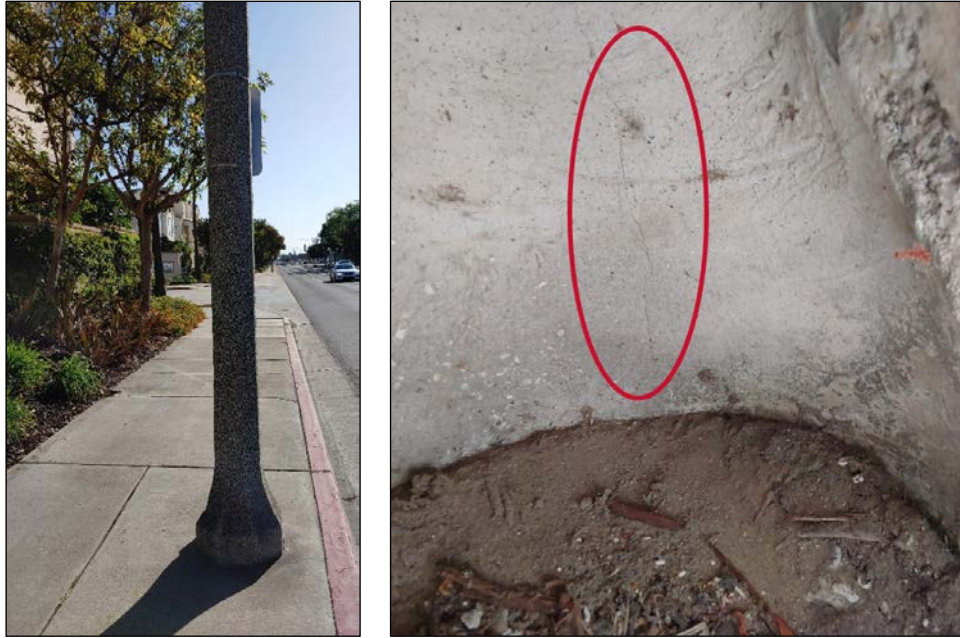
No cracks were observed on the exterior of either the north or south pole. A small superficial crack was observed on the interior of the north pole. The concrete around the south banner pole was cracked, possibly from loading due to tension from the steel cable attached to the top of the pole and/or deficiencies in anchor depth.

Figure 16 – Interior Crack in North Banner Pole, Site #8

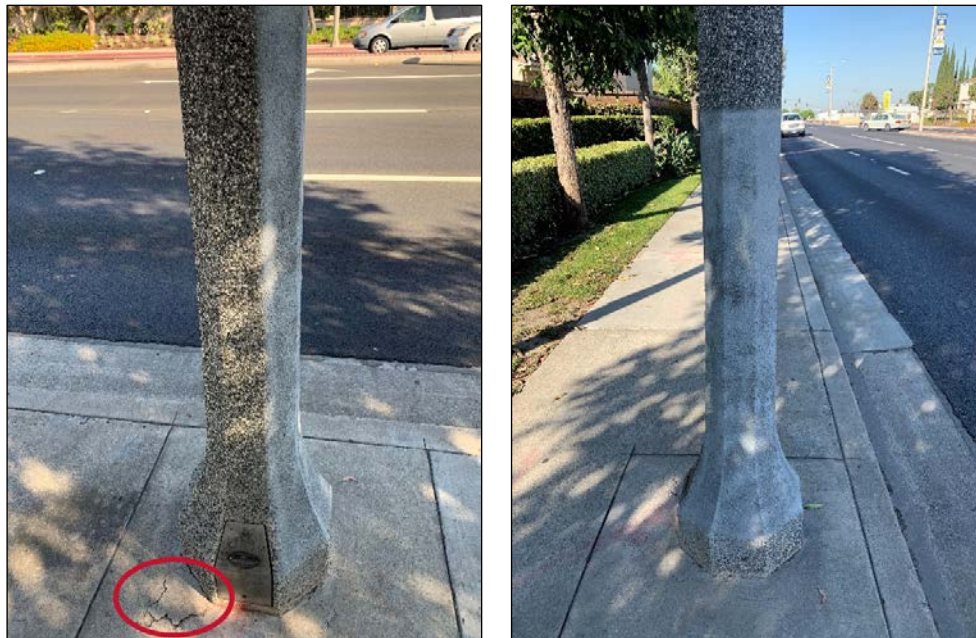
Figure 17 – South Banner Pole, Site #8
