GARDEN GROVE PUBLIC WORKS DEPARTMENT SERVICE REQUEST #429575

Request: NPDES COMMERCIAL INSPECTION OF TOYOTA PLACE OF GARDEN GROVE

Location: 9444 TRASK AVE,

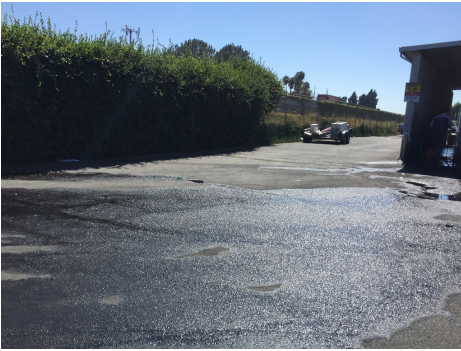
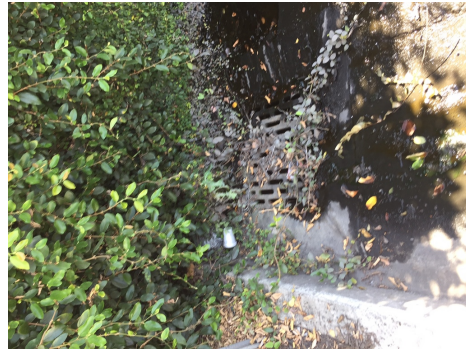
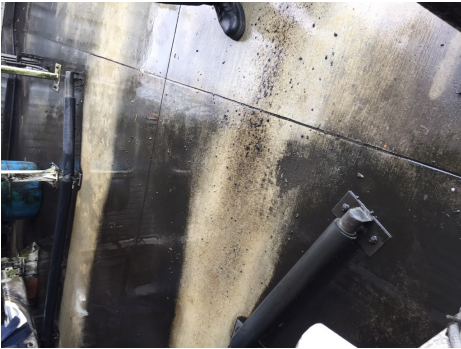
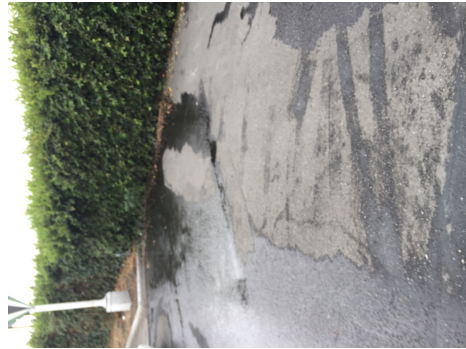
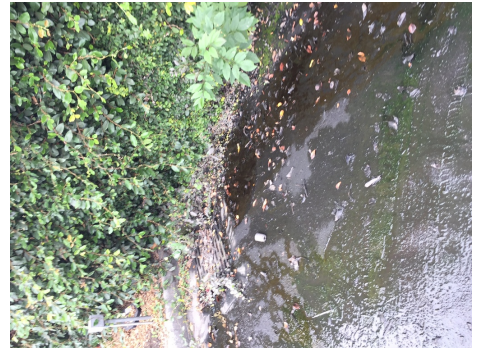
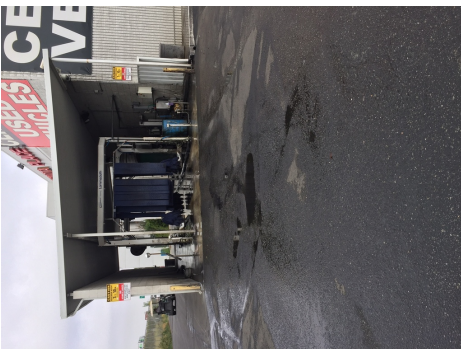
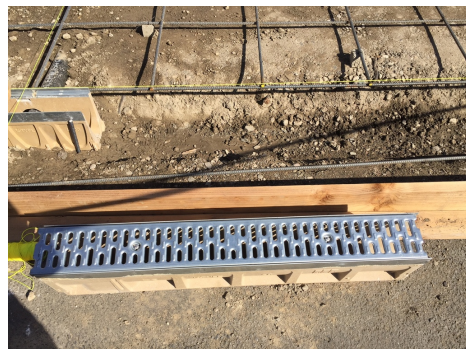
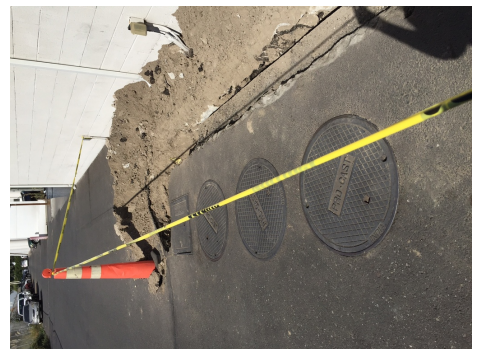
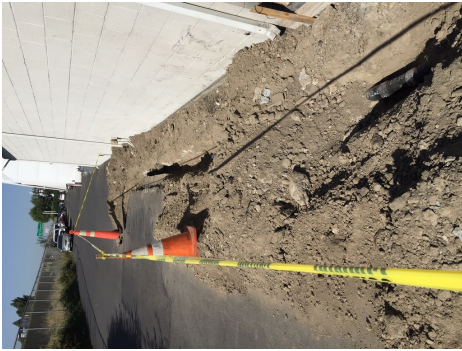
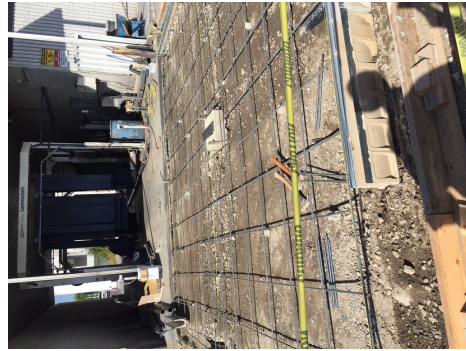
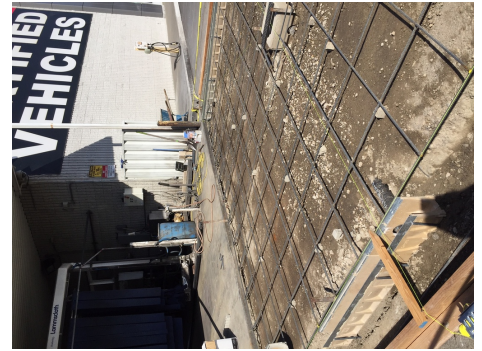
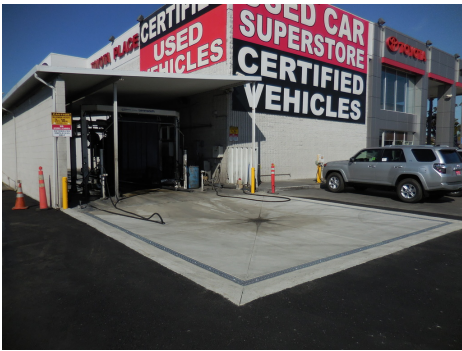
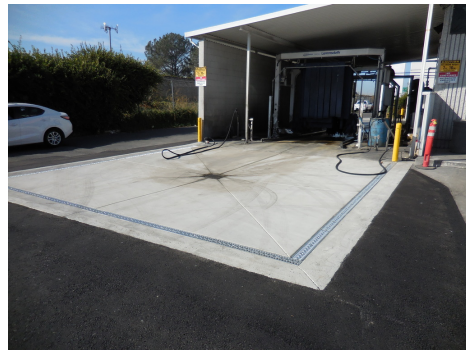
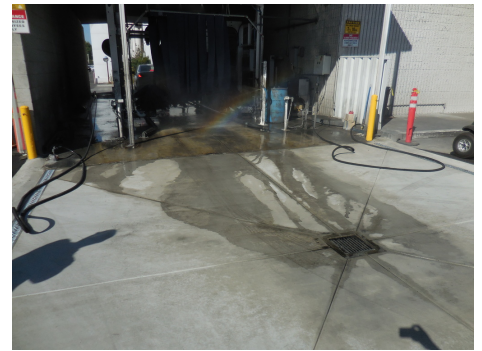
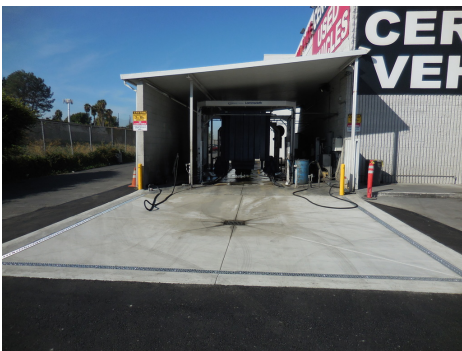
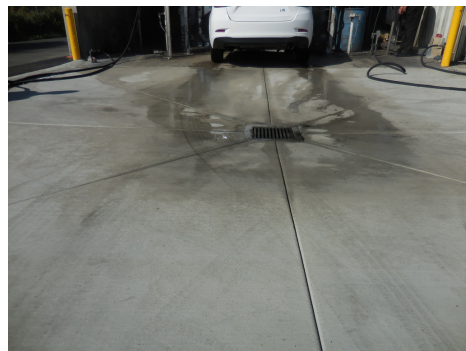
Photos for Workorder #429575

Note #1 (08/10/17 by liag): A JOINT FOLLOW-UP INSPECTION WITH A. J. HOLMON, SUPERVISOR WAS CONDUCTED ON 8/9/2017. MET WITH PAT PETTY, SERVICE DIRECTOR ONSITE AND DISCUSSED REGARDING THE LIQUID DISCHARGE FROM THE CAR WASH AREA TO THE STORM DRAIN AND TO THE CAL TRANS BIO SWALE. HE STATED THAT THE PRESSURE WASH OUTSIDE THE CAR WASH HAS BEEN LOCKED OUT AND THE HOSES HAVE BEEN REMOVED IN ORDER TO DISCONTINUE THE PRE WASH OF CARS. ADVISED MR. PETTY, THAT THE WATER FLOWING FROM THE CAR WASH AREA NEEDS BE DISCHARGED IN A PROPER MANNER AND THAT A TRENCH DRAIN IS REQUIRED TO BE INSTALLED AT THE ENTRY OF THE CAR WASH AREA IN ORDER TO CATCH THE WATER AND PREVENT IT FROM FLOWING INTO THE ADJACENT STORM DRAIN. IN ADDITION, HE WAS INFORMED THAT A NOTICE OF CORRECTION MAYBE FORTHCOMING FOR THE FACILITY BY THIS DEPARTMENT.

Note #2 (10/17/17 by liag): ON 10/9/17, A CONSULTATION WAS CONDUCTED WITH SAM, MANAGER. VISITED THE CAR WASH AREA AND OBSERVED THAT A PREWASH SECTION HAS BEEN ADDED ADJACENT TO THE ENTRANCE. A DRAIN WAS OBSERVED BUILT IN THE CENTER AND A BERM WITH TRENCH DRAINS ALONG THE PERIMETER OF THE NEWLY CONSTRUCTED AREA IN ORDER TO CONTAIN THE LEAKING WATER DURING CAR WASH ACTIVITIES. THE CENTRAL DRAIN WAS OBSERVED BEEN CONNECTED TO THE CLARIFIER LOCATED NEAR BY. ADVISED MANAGER TO COMPLETE THE PROJECT AND NOTIFY THIS DEPARTMENT UPON COMPLETION.

Note #3 (10/17/17 by liag): A JOINT FOLLOW-UP AS PER MANAGER'S REQUEST WAS CONDUCTED ON 10/17/17 REGARDING THE PREWASH AREA. ON THIS DATE THE CONSTRUCTION AT THE AREA HAS BEEN COMPLETED AND NO WATER WAS OBSERVED LEAKING TOWARDS THE CALTRANS STORM DRAIN DURING CAR WASHING ACTIVITIES. THE VIOLATIONS WERE CORRECTED.

Comments: SPOKE WITH PAT PETTY, PARTS AND SERVICE DIRECTOR. OBSERVED LIQUID FROM THE CAR WASH/PRE-WASH AREA LOCATED IN THE SOUTH WEST SIDE OF THE PROPERTY, DISCHARGING INTO THE ADJACENT STORM DRAIN AND TO THE CAL TRANS BIO SWALE. THE STORM DRAIN WAS OBSERVED DIRTY AND COVERED WITH SLIME AND DIRT. NO

BMPS HAVE BEEN IMPLEMENTED ONSITE. A NOTICE OF CORRECTION MAY FORTHCOMING TO THIS FACILITY (REFER TO ATTACHMENTS). CITY AND NPDES REGULATIONS WERE DISCUSSED. EDUCATIONAL BROCHURES WERE PROVIDED. PHOTOS WERE TAKEN.
