Appendix H: Phase I Environmental Site Assessment

**PHASE I ENVIRONMENTAL SITE ASSESSMENT REPORT FOR
COMMERCIAL PROPERTY LOCATED AT 13040 COAST STREET,
WITHIN THE CITY OF GARDEN GROVE, CALIFORNIA**

CEC Project Number 22-2425
October 29, 2022

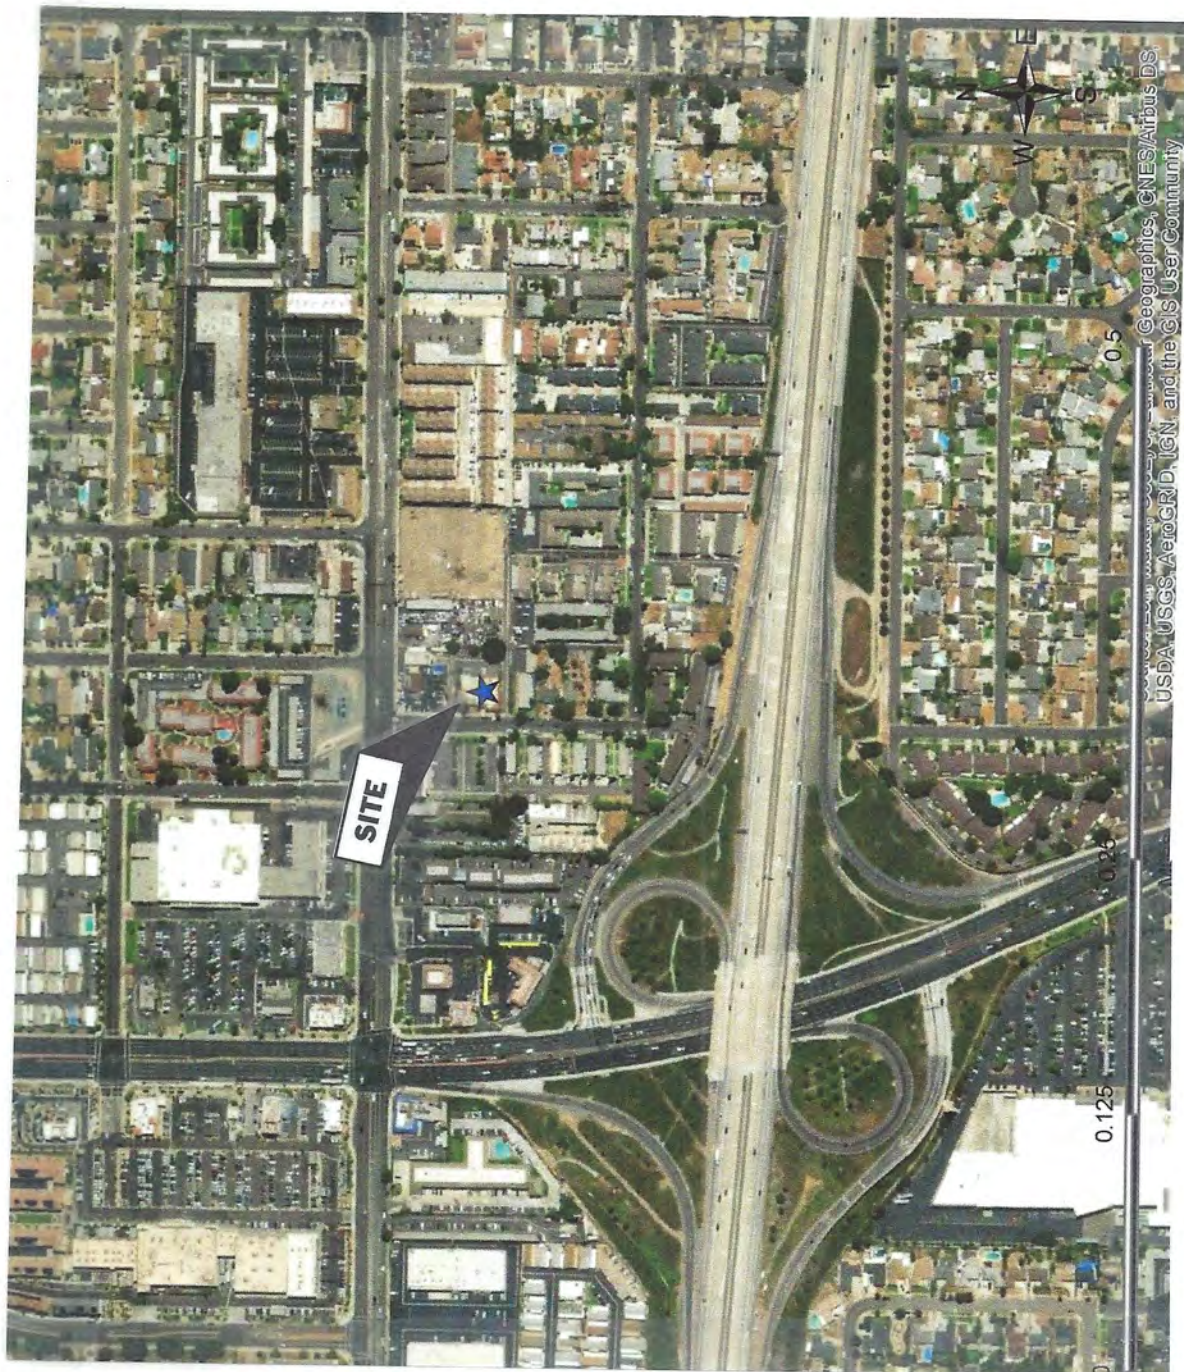
Recent Aerial Photograph
13040 Coast Street
Garden Grove, California

The existing site building and grounds could be seen in the 1972 and more-recent aerial views. The site appeared to have remained generally unchanged since the mid-1970s. No large-scale TSD-type facilities, such as railroad facilities, waste-disposal/treatment ponds, land-filling operations, oil wells and/or tank farms, were observed at the site in these historical aerial photographs.

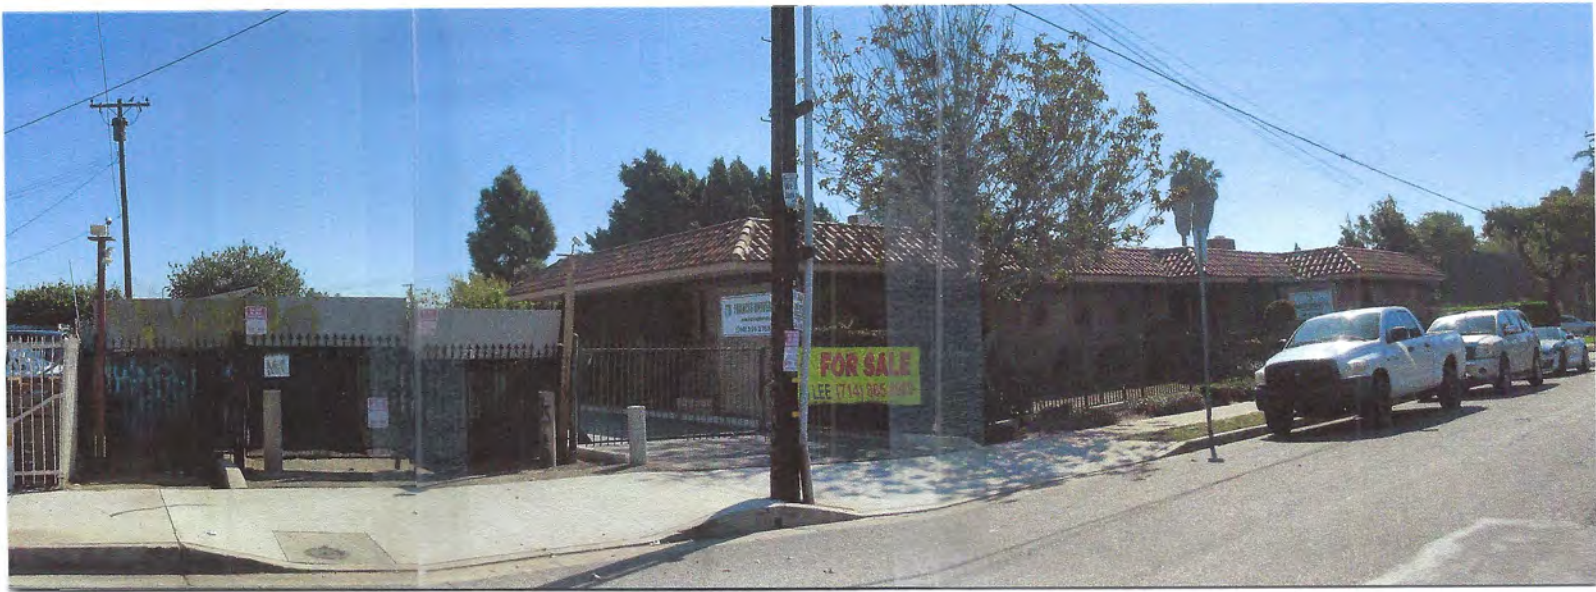
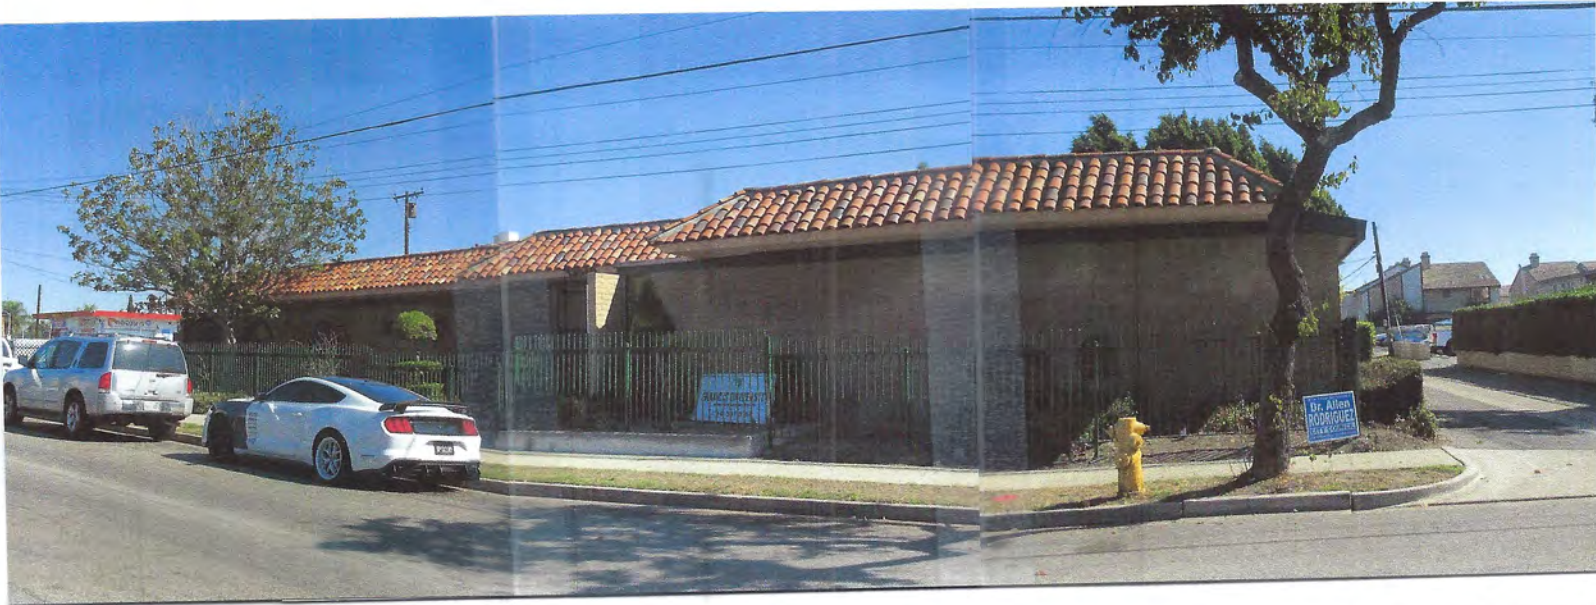
Photographs 1, 2 and 3 - Easterly to southeasterly view of the site and adjacent properties and roadway, as seen from a point across Coast Street; northeastern to easterly view of the site and adjacent properties and roadway, as seen from a point across Coast Street; and a westerly to northwesterly view of the site and adjacent properties and alley way, as seen from a point on the nearby-south residential property.

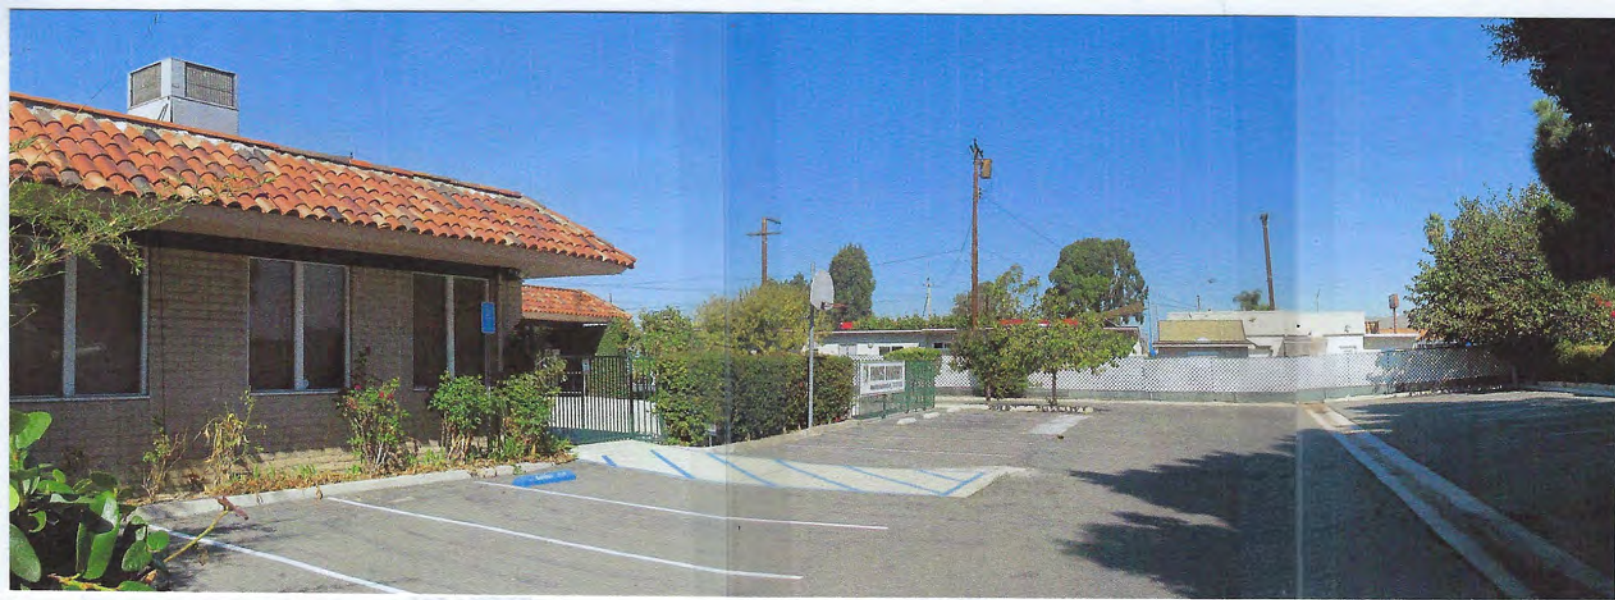
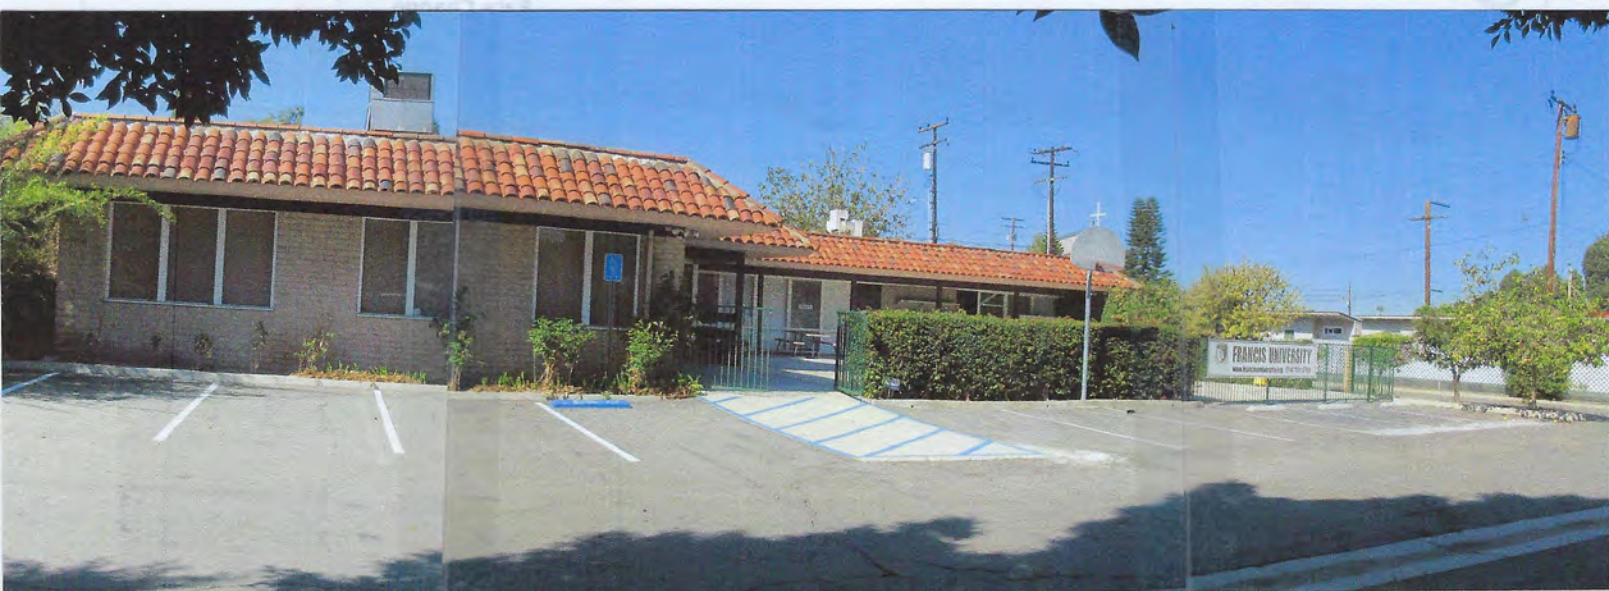
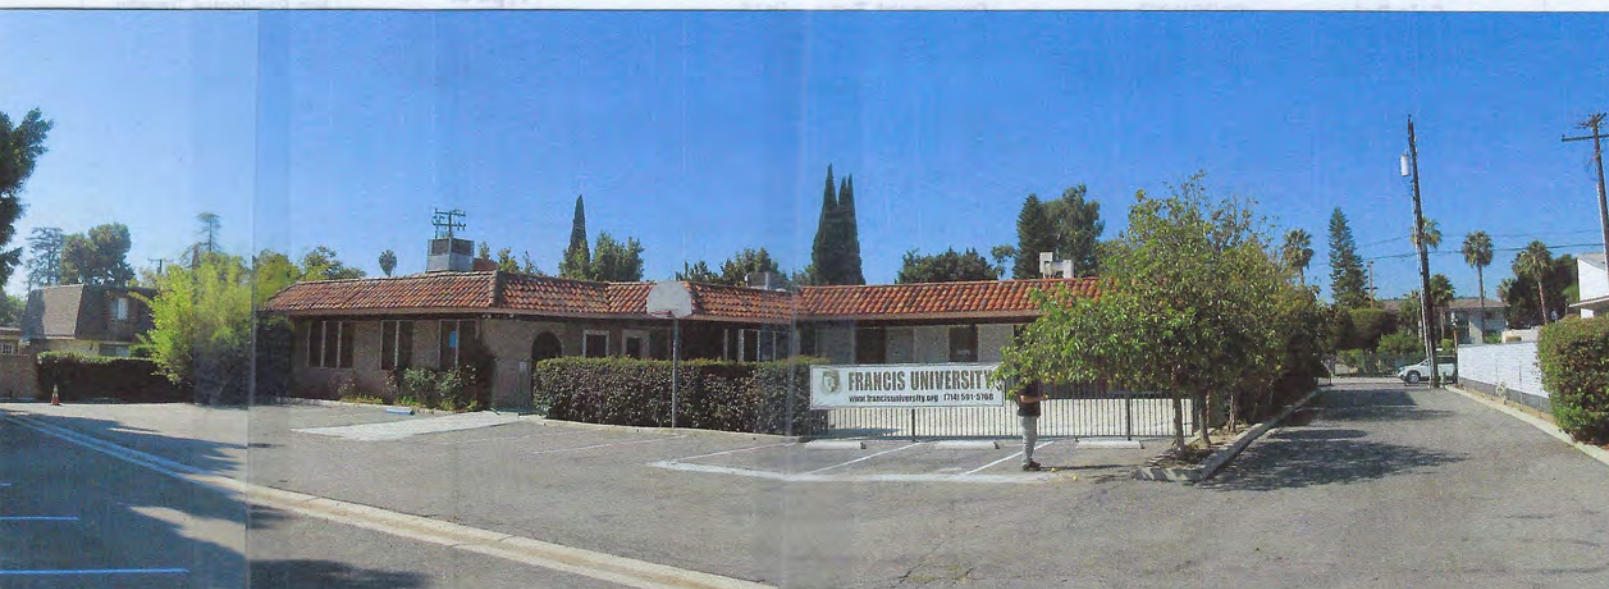
Photographs 4, 5 and 6 - Northwesterly to northerly view of the site and adjacent properties, as seen from a the southeastern part of the parcel; westerly to northwesterly view of the site and adjacent properties and roadways, as seen from near the central-eastern edge of the parcel; and southwesterly to westerly view of the site and adjacent properties, from a point near the northeast corner of the subject parcel.
