City of Garden Grove

Banner Pole Condition Assessment

Garden Grove, CA
November 7, 2019

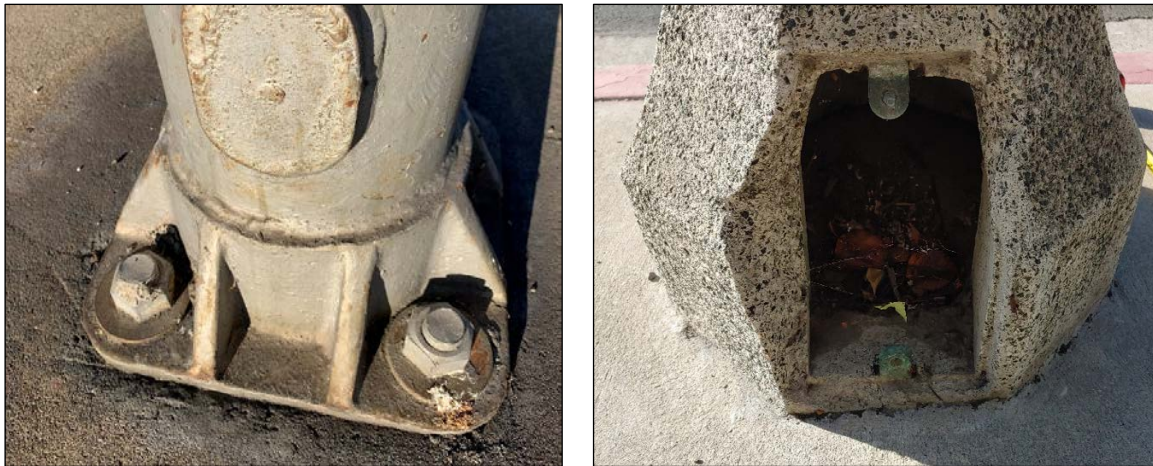
Figure 2 – Flanged Metal Pole with J-bolts (Left), Cast Concrete Pole Embedded in Concrete (Right)

were conical in shape with precast concrete foundations level with the ground. Pole bases were either embedded in concrete or anchored by bolts secured to a welded flange, with the exception of one pole that was embedded directly in soil. The two foundation types are shown in Figure 2.
