# GARDEN GROVE SANITARY DISTRICT SEWER SYSTEM MANAGEMENT PLAN APRIL 2020

### GARDEN GROVE SANITARY DISTRICT

### SEWER SYSTEM MANAGEMENT PLAN

### April 2020

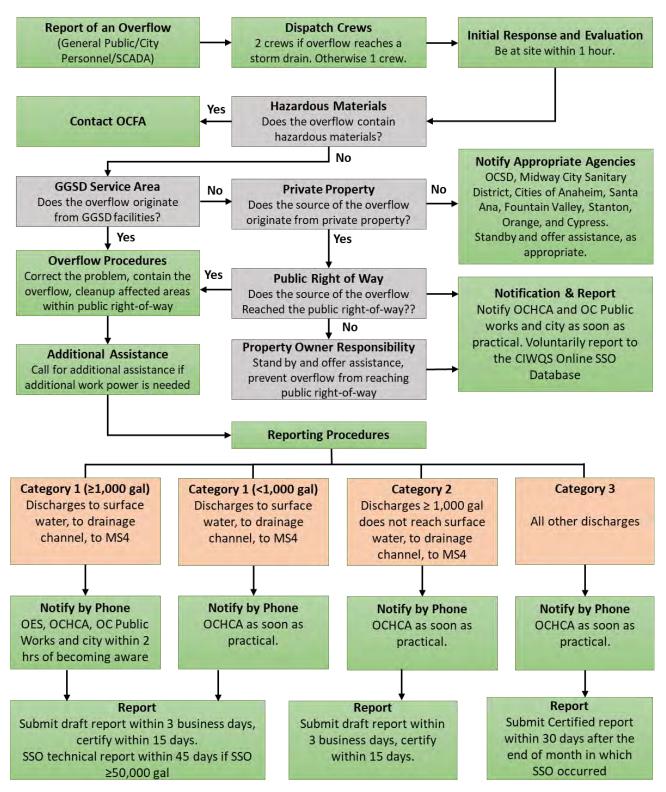
#### Figure 3-3 SSOERP Response Procedures

The District has prepared a stand-alone document for the Sanitary Sewer Overflow Emergency Response Plan (SSOERP) element of the SSMP requirements. It includes a list of individuals and agencies that need to be contacted in the event of a sanitary sewer overflow (SSO). Figure 3-3 details the procedures to respond to SSOs. The Sanitation Supervisor will be the responsible staff to report the SSO to the State Water Board and other appropriate agencies.

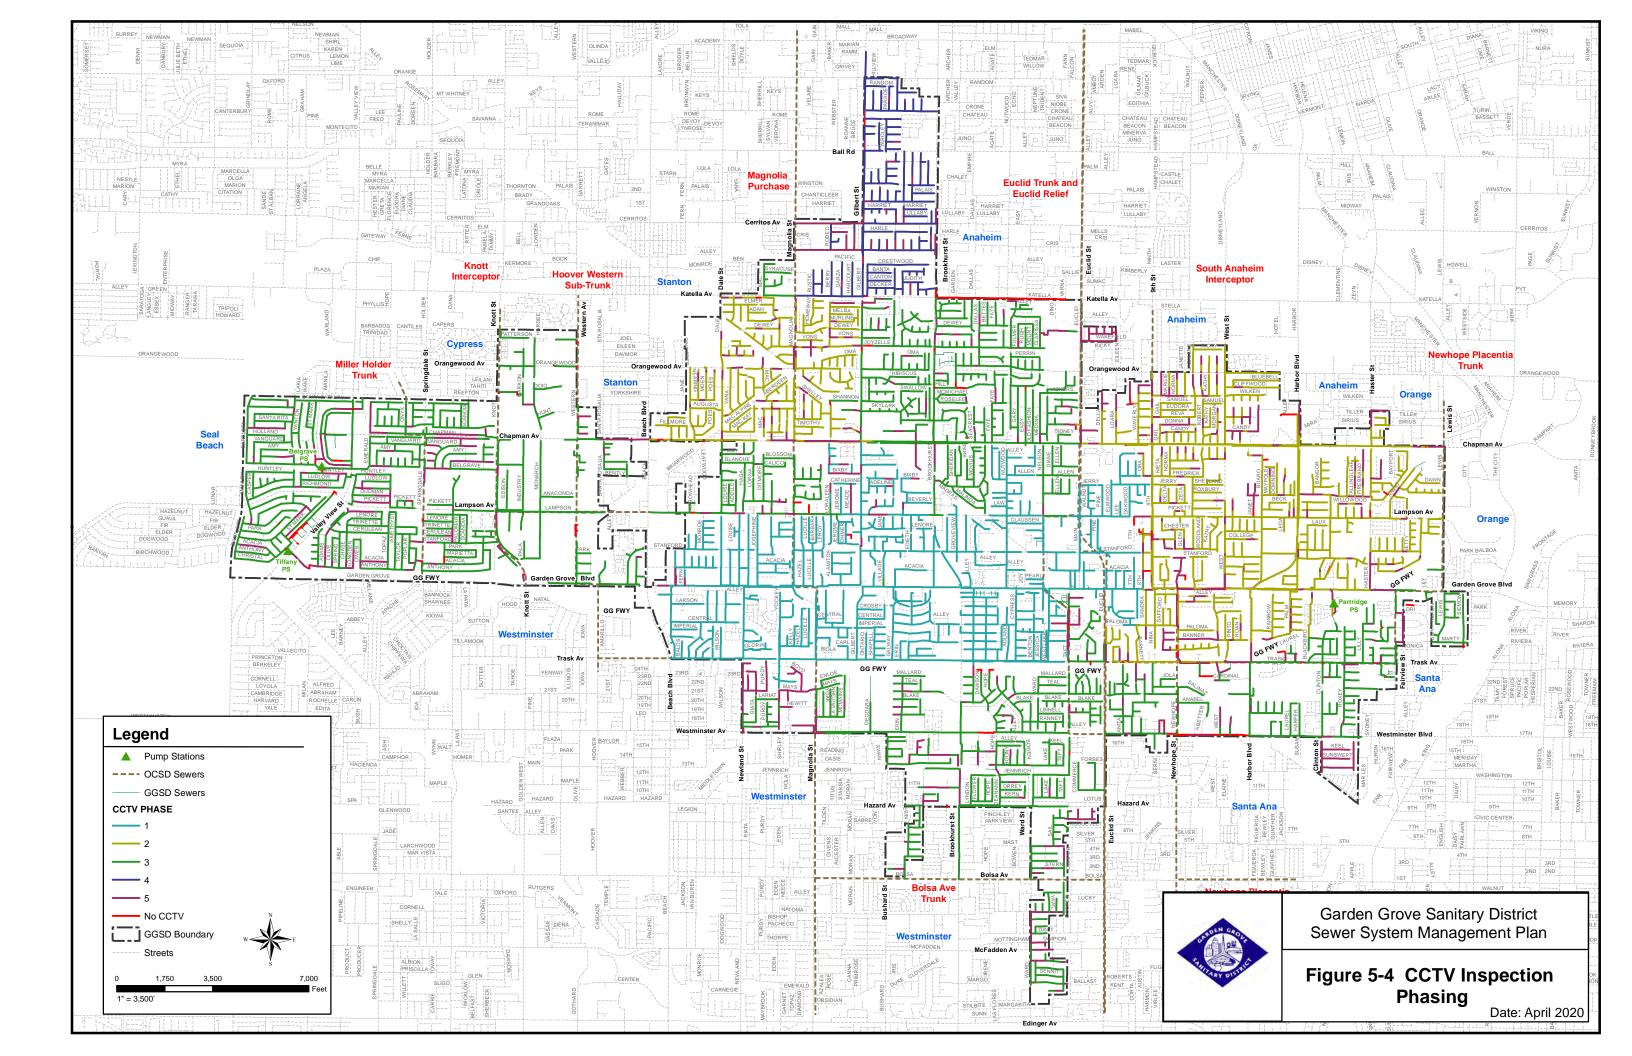
**Phase 4** of the CCTV inspection was completed in 2008 to evaluate the condition of the District's sewers that are located within the unincorporated Orange County areas, generally north of Katella Avenue, between Magnolia Street and Brookhurst Street.

**Phase 5** of the CCTV inspection was completed in 2012 with the intent to complete the condition assessment of the District's gravity sewers and to reevaluate the sewers that were identified to have condition deficiencies from the previous four (4) phases.

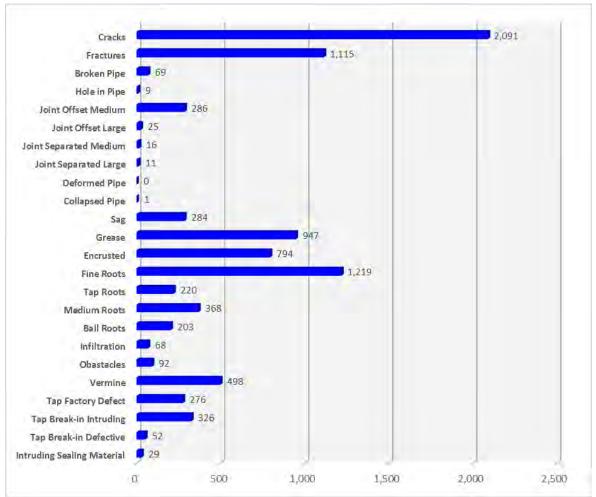
Figure 5-5 Sewer Reaches with Identified Deficiencies

Figure 5-5 shows the number of reaches where an identified deficiency was found at least once within the reach. It provides a general sense of the magnitude of the problems that were found in the portion of the District's collection system that was CCTV inspected. The problems identified most were cracks (2,091 reaches, 30% of Total), fine roots (1,291 reaches, 18% of total), and fractures (1,115 reaches, 15% of total).

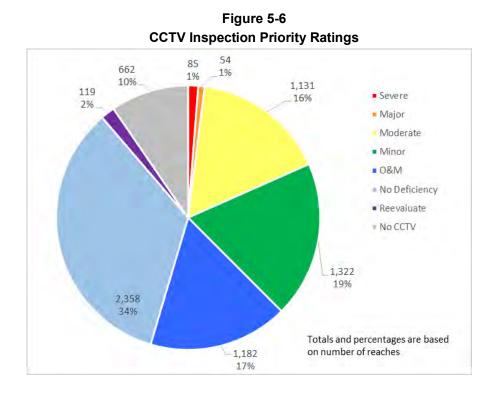
Figure 5-6 illustrates the distribution of the comprehensive sewer priorities for the District's gravity sewer system.

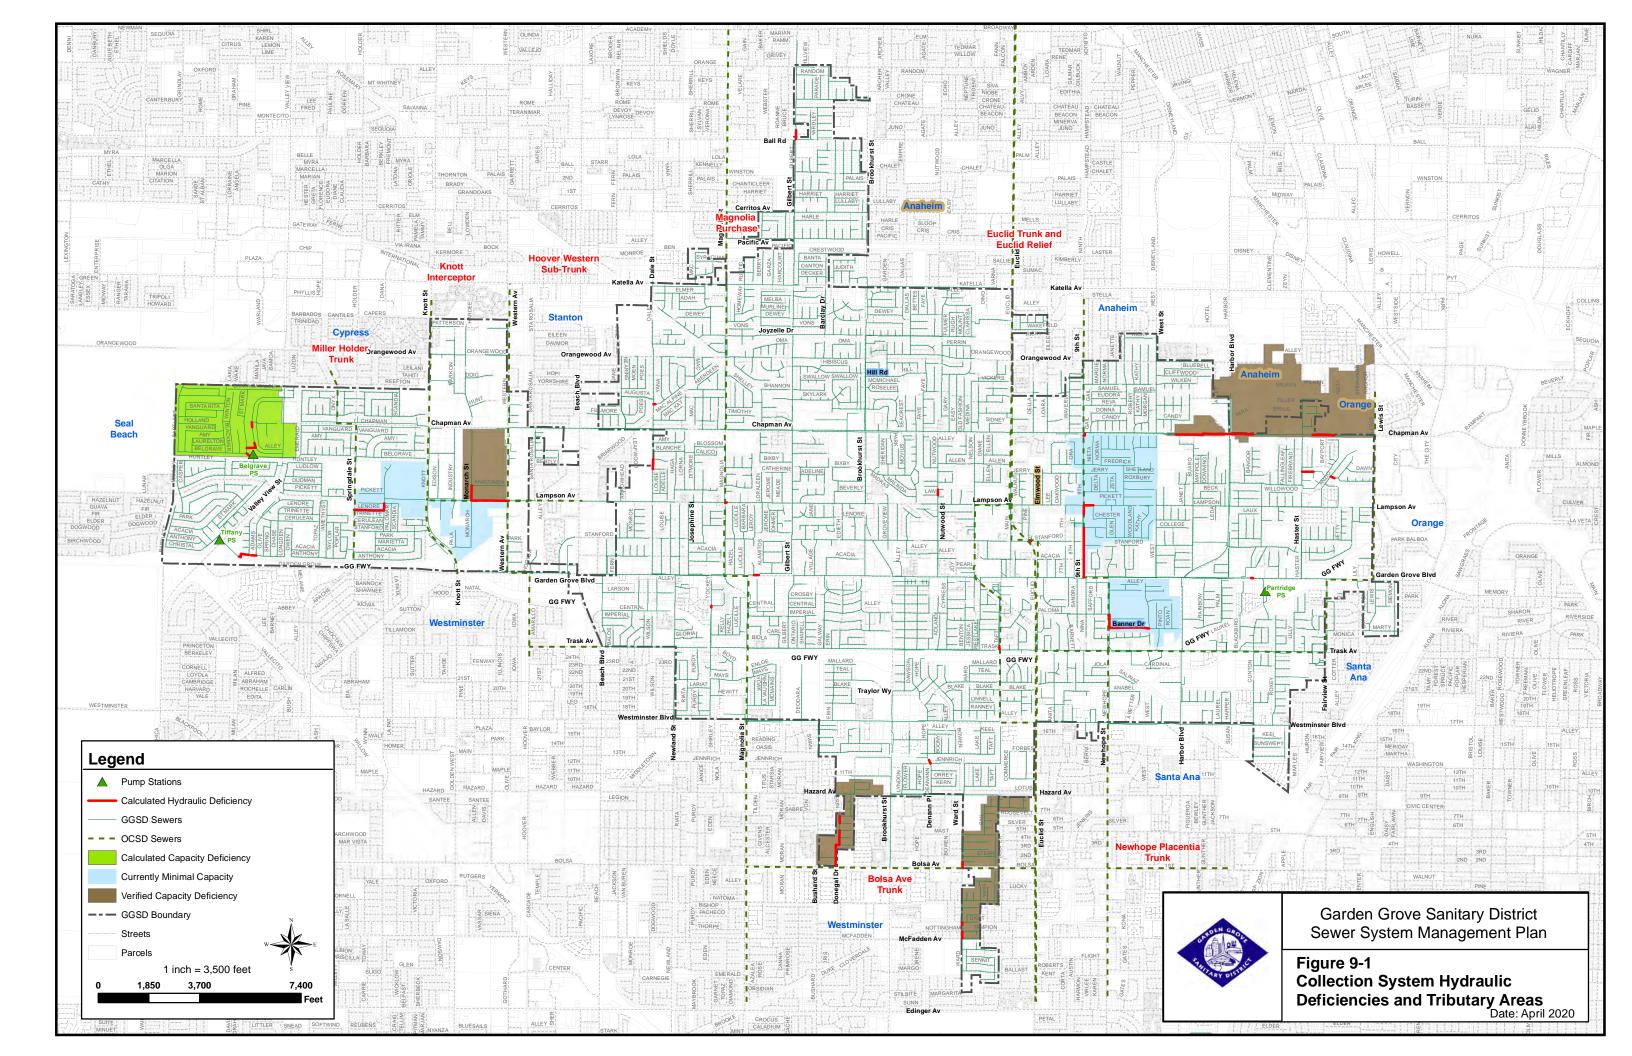
The Capital Improvement Program for capacity improvements is formulated to eliminate the deficiencies in accordance with Garden Grove Sanitary District's criteria. It consists of replacement with larger pipes, diversions to adjacent or nearby Orange County Sanitation District facilities, diversions to Garden Grove Sanitary District facilities with adequate capacity, or combinations of these.

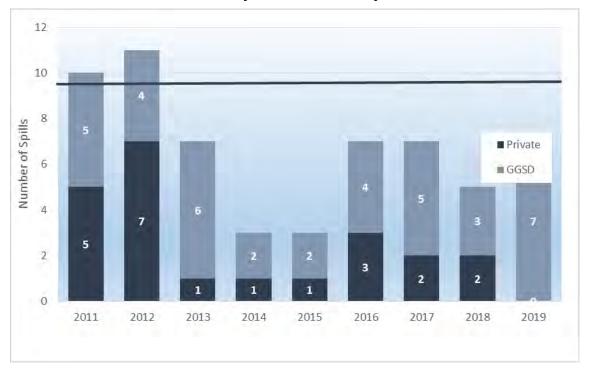
Figure 10-1 Sanitary Sewer Overflows by Year

The SSO trends are detailed on Figure 10-1 and Table 10-2. Table 10-3 summarizes all SSOs since 2011. A map of the SSO locations is included on Figure 10-2. The number of SSO from 2016 to 2019 maintained below threshold level of 9.6 spills.
